January 9, 2004
Project No.: 03-038

Subject: Preliminary Inspection of the Sugar Mill Facility

We have completed a preliminary inspection of the Sugar Mill. The intent of the inspection was to give a cursory assessment of the structural integrity of the facility in order to determine if asbestos remediation and subsequent demolition are feasible without first conducting major structural work. The scope of our inspection included visual assessment of the primary structural elements of the facility including the steel columns and beams, concrete floor slabs, exterior walls, and roof. This letter summarizes the findings of the inspection and highlights areas of structural concern.

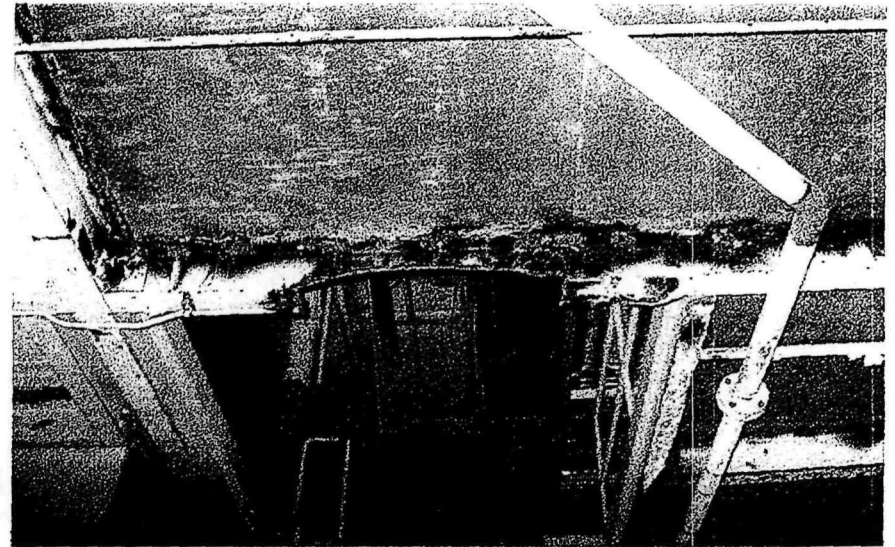
Most of the steel beams and columns appear intact and show only minor corrosion or deterioration. There are isolated instances where beams or columns have been damaged as shown in Photographs 1-2. As a general rule, the steel beams above boilers and other equipment show significant corrosion as shown in Photograph 3. These areas do not threaten the overall integrity of the structure but should be assessed individually before proceeding with work near them. Specific areas of damage are noted on the accompanying sketches.

Photograph 2 - Beam Cut at Stairway Opening

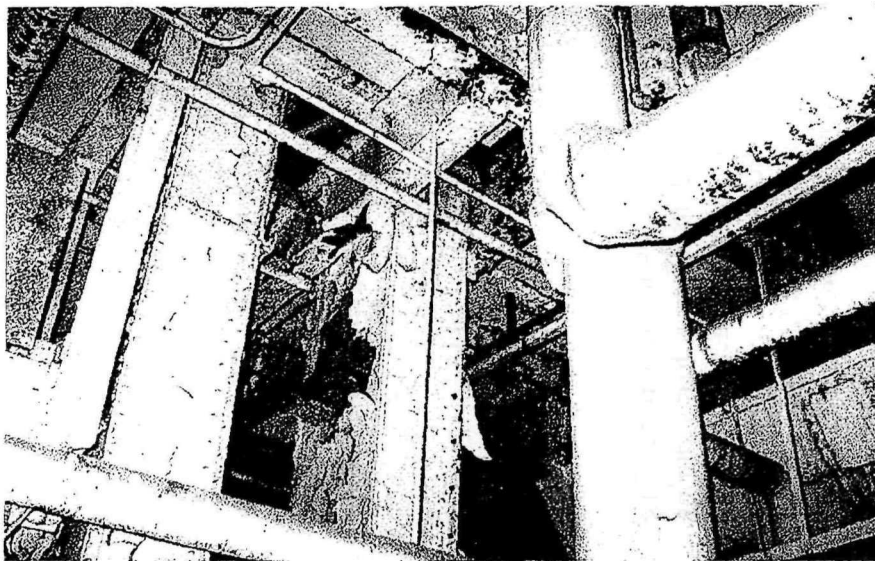
Photograph 3 - Corrosion Near Boiler

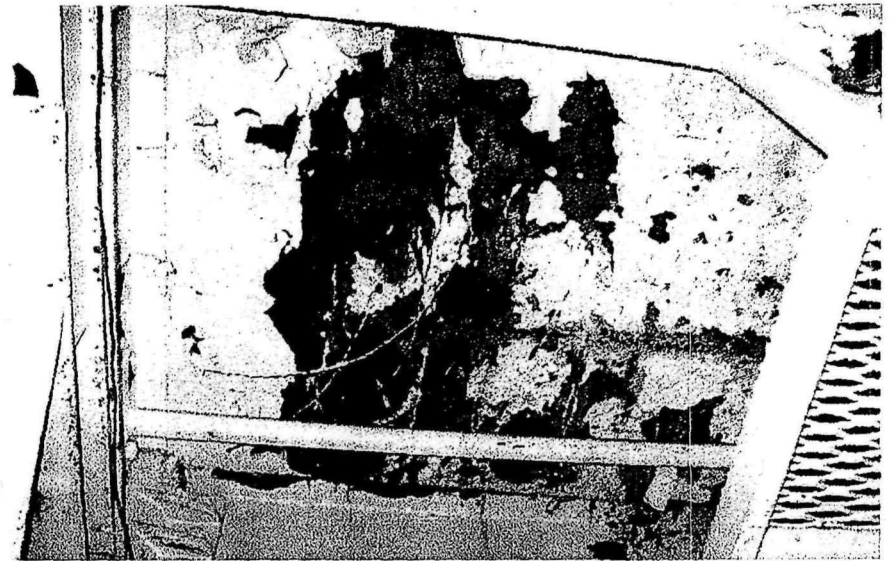
The condition of the floor slabs is suspect. The structural integrity is difficult to determine visually, but it is apparent that the slabs are thin and possibly insufficiently reinforced. In many areas the concrete on the bottom side of the floors has fallen off and the reinforcement is exposed as shown in Photographs 4-5. In some of these areas, the reinforcement appears to be barbed wire. Barbed wire reinforcement would not be

Photograph 4 - Deteriorated Floor Slab with Exposed Reinforcement

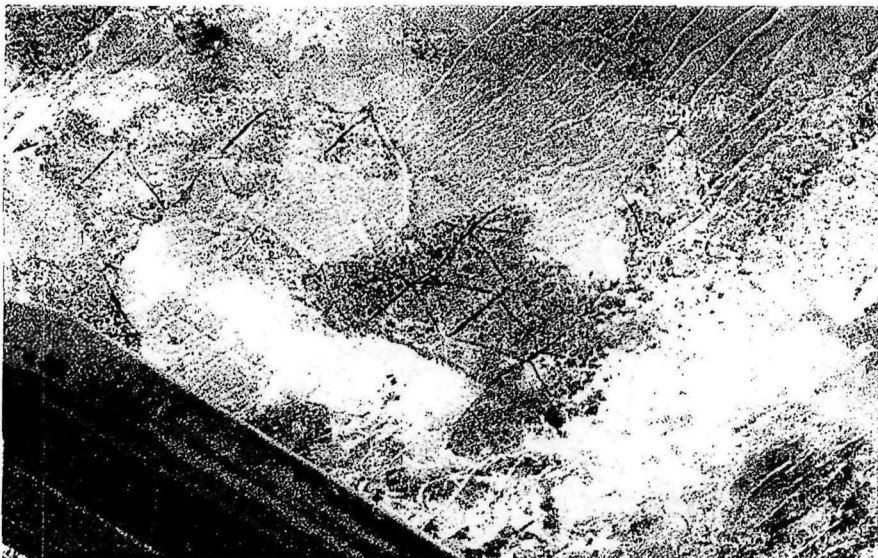
Photograph 5 - Deteriorated Floor Slab with Exposed Reinforcement

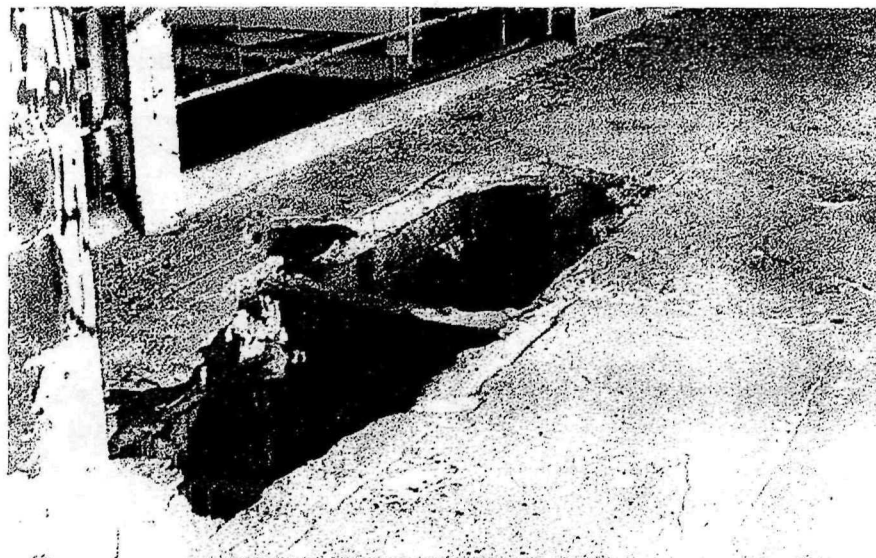
expected to perform well and it is apparent that it has deteriorated in many areas. In several locations, there are holes in the floor slabs as shown in Photographs 6-7. The condition of the floors does not jeopardize the overall integrity of the structure but the floors should not be relied on to support significant loads. In lieu of detailed structural investigation and analysis, the slabs would need to be shored or reinforced before supporting significant additional loads. Alternatively, it would be possible to construct temporary flooring on top of the slabs that would span across the floor beams and carry the applied loads. In areas where concrete is falling off of the bottom of slabs, it may be necessary to construct overhead protection to prevent concrete from falling on workers below. Specific areas of weakness are noted in the accompanying sketches.

Photograph 6 - Hole in 4th Floor Slab

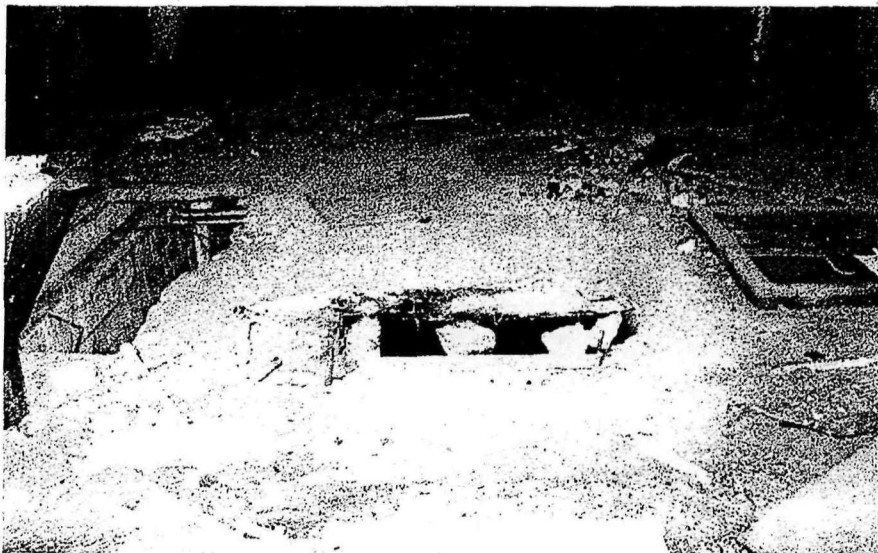
Photograph 7 - Holes in 2nd Floor Slab

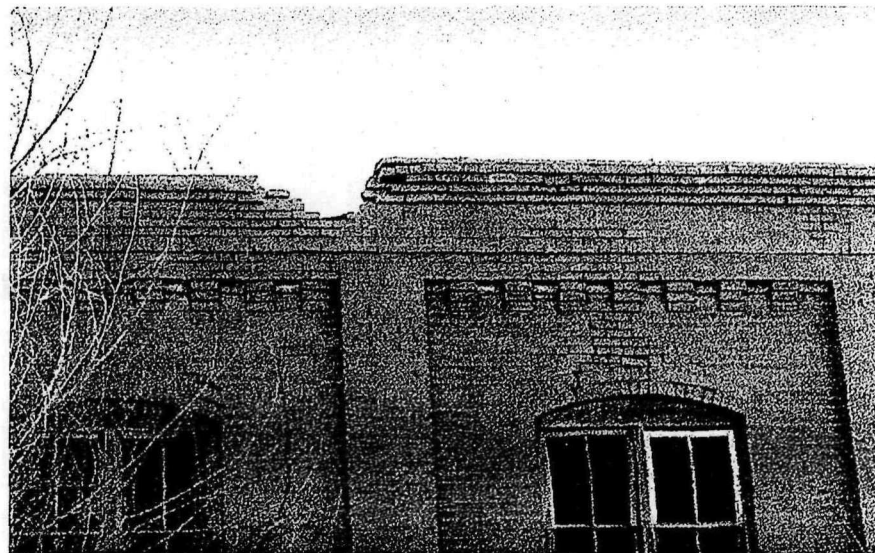
In general, the exterior brick walls appear sound; however, there are some holes and loose bricks in areas. Many bricks along the roof parapet are loose or missing as shown in Photographs 8-9. The southwest corner of the building is damaged and has many loose and missing bricks as shown in Photograph 10. There is a fairly large hole on the east side of the south end of the building as shown in Photograph 11. In all of these areas, the loose bricks should be removed or stabilized before other work begins. The arches above many of the windows are deteriorated as shown in Photograph 12. The window openings in areas such as these should be shored to prevent collapse. Many of the window openings have been shored already with mortar or wood framing. The damage noted in these areas is primarily superficial and does not affect the integrity of the structure, but proper precaution should be taken to prevent bricks from falling on workers below. Damaged areas are noted on the accompanying sketches.

Photograph 8 - Loose Bricks at Roof Parapet

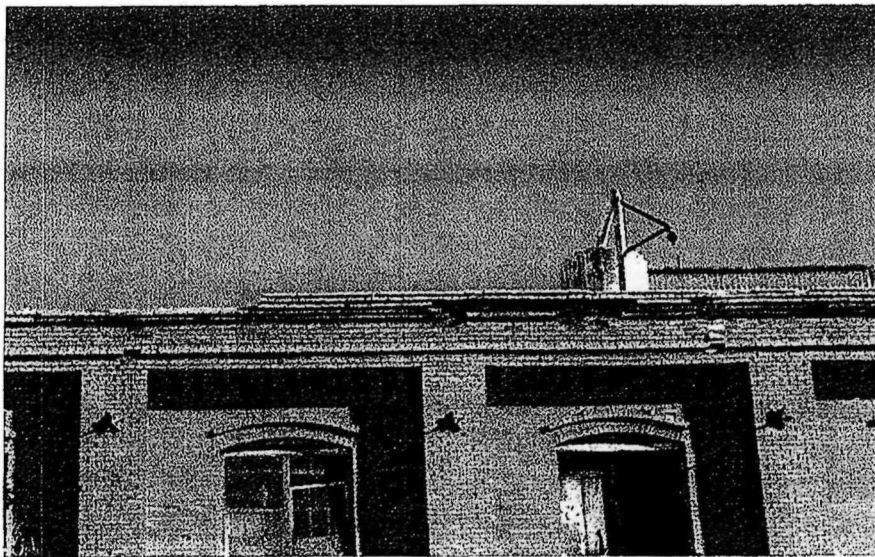
Photograph 9 - Loose Bricks at Roof Parapet

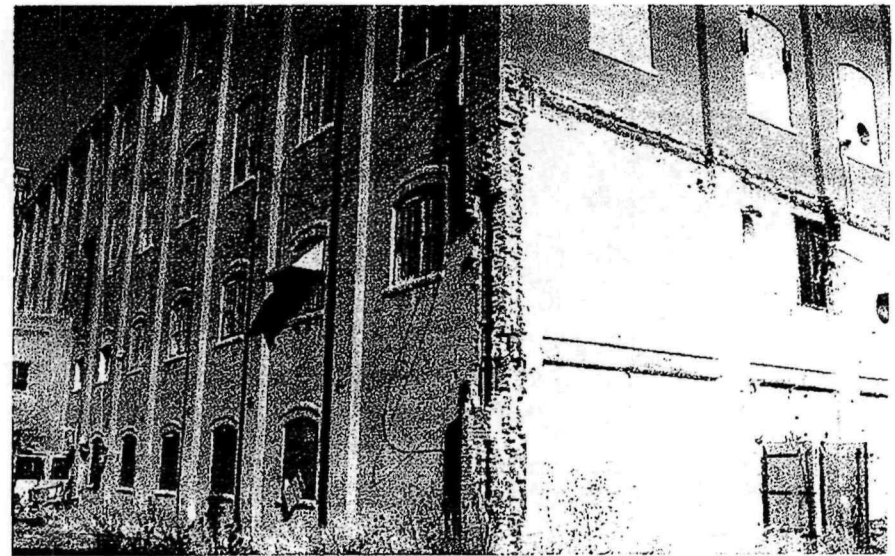
Photograph 10 - Loose Bricks at Corner

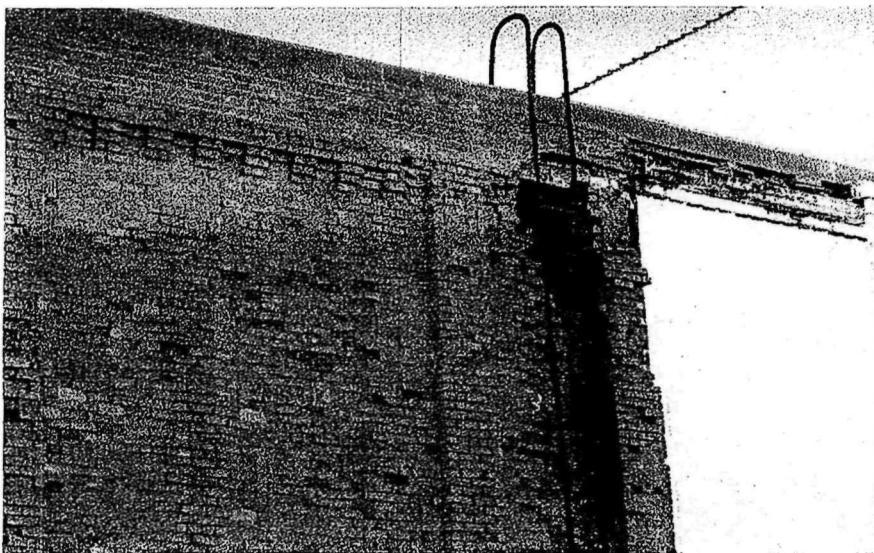
Photograph 11 - Hole in East Side of South End of Building

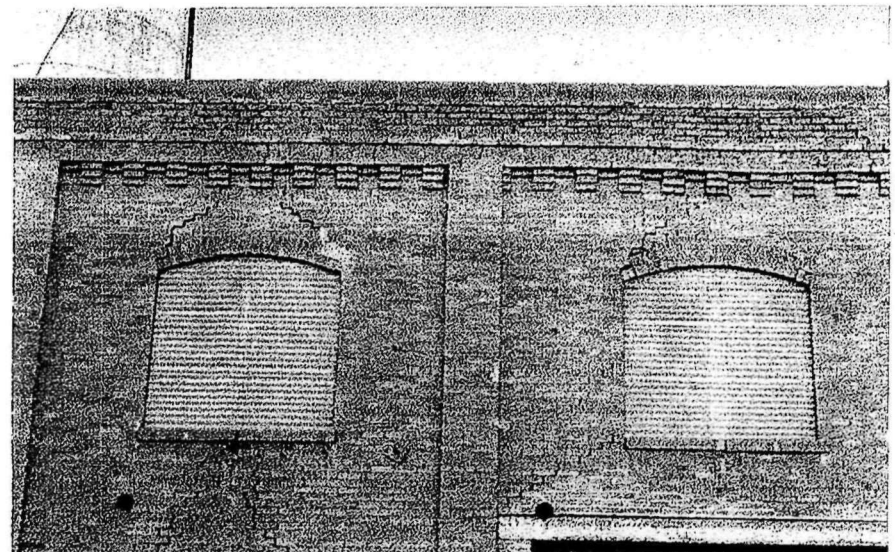
Photograph 12 - Deteriorated Arches Over Window Openings

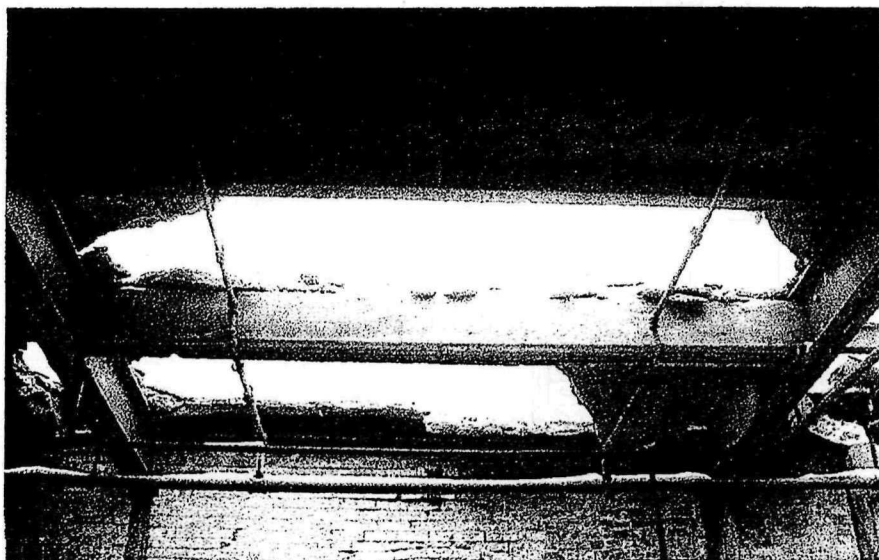
There are some holes in parts of the roof of the facility as shown in Photographs 13-14; but, in general, the roof is in fair condition. The roof itself is not expected to carry significant loads during remediation or demolition work; however, care should be taken to prevent debris from falling through the holes in the roofs or onto the lower roof of the east side of the structure when working on the higher floors of the west side of the structure. A wood-frame structure exists on the roof of the northeast portion of the facility as shown in Photographs 15. It was inaccessible but it appears unstable. This portion of the structure should be removed in its entirety before working near or under it. If this structure contains asbestos, it will be more complicated than normal to demolish. Areas of the roof that are of specific concern are noted on the accompanying sketches.

Photograph 13 - Holes in Roof

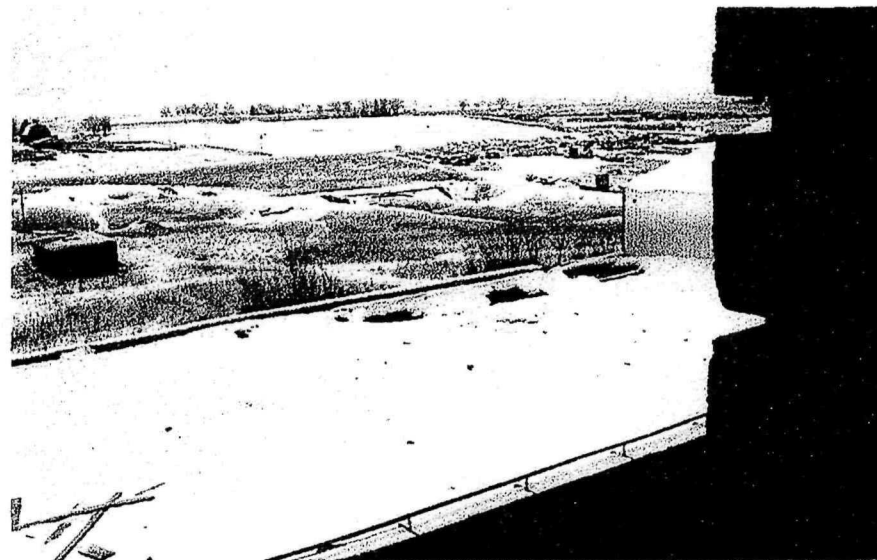
Photograph 14 - Holes in Roof

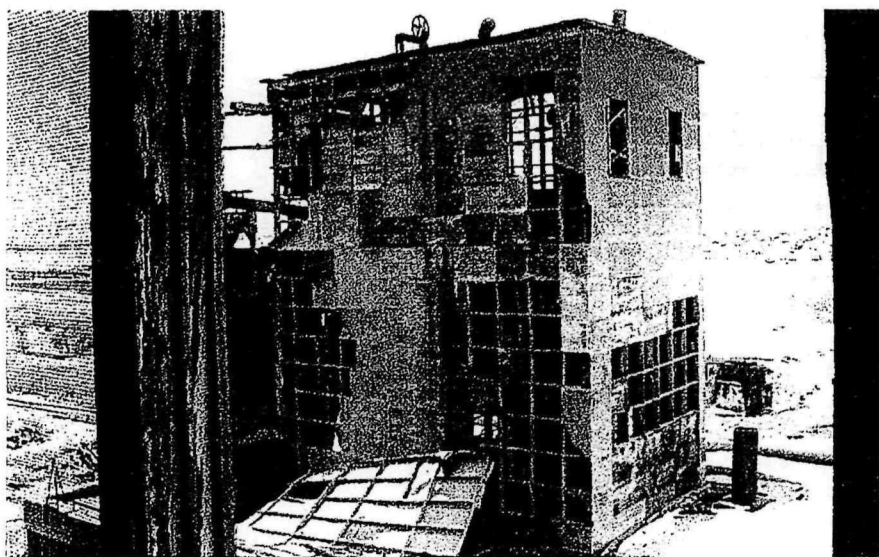
Photograph 15 - Structure on Roof of Northeast Portion of Facility

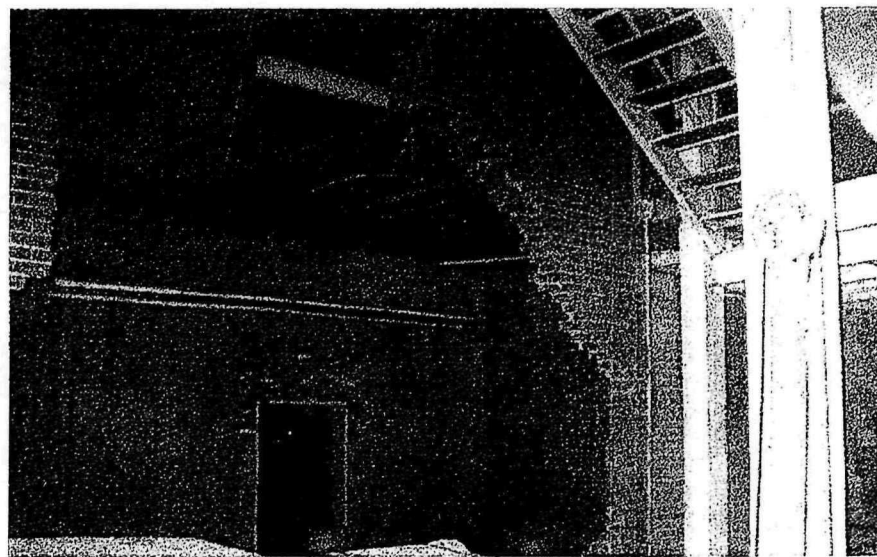
A partially demolished brick wall exists in the southeast wing of the first floor as shown in Photograph 16. This wall is unstable and should be demolished in its entirety before proceeding with work in the vicinity. A damaged concrete block partition wall also exists on the south wall of the same area. It should be completely demolished prior to conducting other work in the vicinity.

Photograph 16 - Partially Demolished Brick Wall

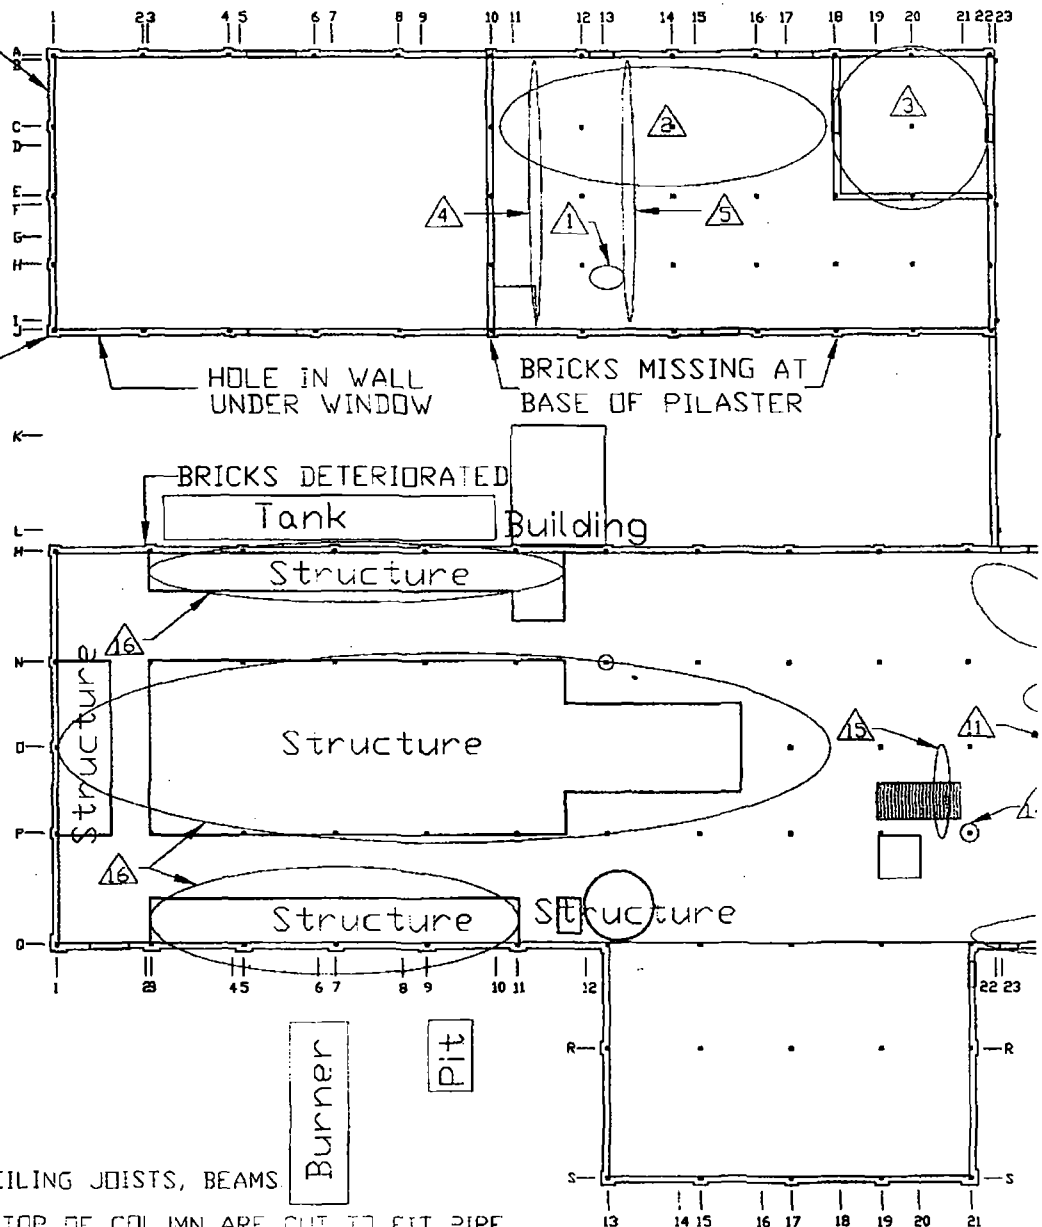
- △1 SIGNIFICANT CORROSION NEAR EXTERIOR WALL. EXPOSED REINFORCEMENT IN CEILING. SIGNIFICANT WA
- △2 REFORCMENT EXPOSED. SIGNIFICANT WATER STAINS BRACE BEFORE LOADING.
- △3 CEILING BEAMS CORRODED & CONCRETE REINFORCEMENT VISIBLE. BRACE BEFORE LOADING.
- △4 WATER STAINS AND CRACKING
- △5 WATER STAINS AND CRACKING

BASE OF WALL MISSING
NEEDS STABILIZATION

BRICKS MISSING

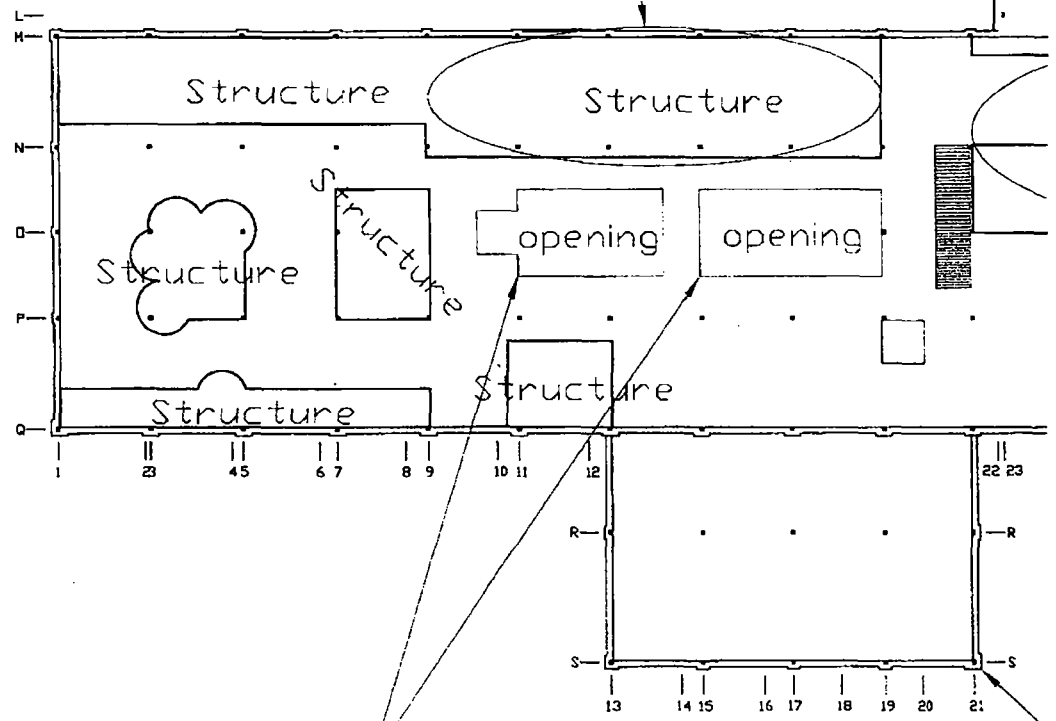
CONCRETE SPALLED OFF OF CEILING
SHORE BEFORE WORKING IN THIS AREA

FLOOR DEFLECTS BENEATH
SHORE BEFORE WORKING

OPENINGS IN FLOOR
COVER BEFORE WORKING IN THIS AREA
